Airborne Debris Test

Windborne missile impact tests were performed on your LEEP STRUCTURAL CORE (LEEP CORE) PANEL SYSTEMS on the 10th of January of this year at the Wind Load Test Facility located at Clemson University, Clemson, South Carolina. The windborne missile impact tests were performed with the use of the facility's air cannon and a Decatur Electronics, Inc. Genesis-I radar gun. The purpose of the testing was to determine whether the LEEP CORE panel systems meet the Large Missile Impact tests as specified in the South Florida Building Code, ASTM E 1996, and the SBCCI standard, SS TD 12.

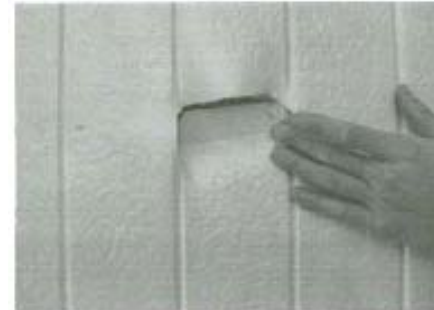
Initial tests were conducted with multiple impacts of the 9-pound 2x4 at a target speed of 34 mph. Two impacts were at 33 mph, several were at 35 mph, but most were at 34 mph. These impacts produced permanent indentations in or perforations of the exterior metal sheeting in all cases. The 34 to 35 mph impact speed for the 9-pound 2x4 wood missile turned out to be close to the threshold velocity for perforation of the exterior metal sheeting. Perforations occurred in three cases out of about 10 impacts. Figure 1 shows a typical exterior surface perforation with a missile speed of 35 mph. However, there was little or no deformation that could be observed on the interior surface of the panels for impacts in this speed range. The largest observable deformations of the interior surface occurred when the missiles struck on or near the vertical channel indentation. Figure 2 illustrates the type of interior surface deformation observed from an impact on or near the vertical channel. This deformation was limited to a slight local buckling of the thin metal interior sheet in the vicinity of the impact.

Typical perforation of exterior metal sheeting (9-pound 2x4 at 35 mph)

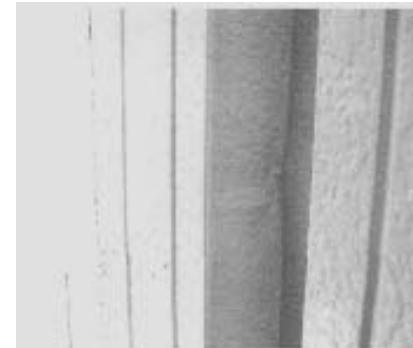
Typical local indentation of interior surface from strike on exterior surface (9-pound 2x4 at 35 mph)

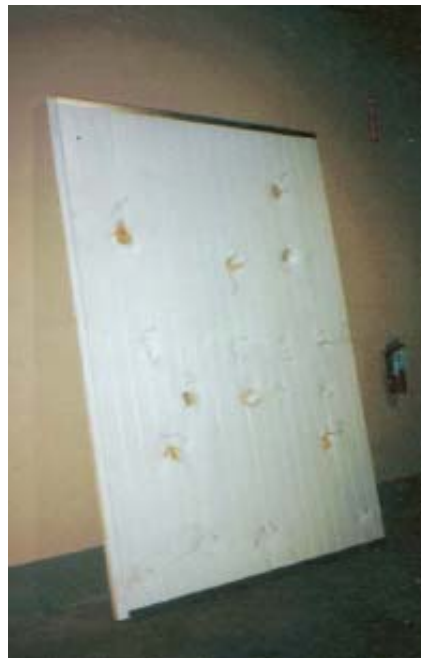
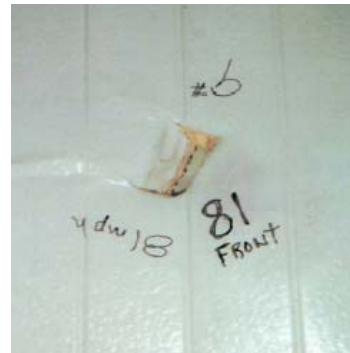
LeapCore wall section resisted penetration of 9 pound wood 2 x 4s, shot on end, at speeds up to and including 81 mph.

Localized wall penetration occurred at 234% of Dade County test specification.

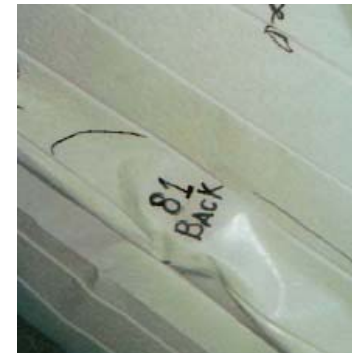
Inside surface bent but not penetrated

At speeds in excess of 90 mph, only local damage occurs and is easily repaired. Flying debris penetrating the LeapCore wall at such excessive speeds, is retained within the wall so humans inside such a building would not have been harmed .
